NO . D3-2780

MODEL	111	CONTRACT	NO	0 0	:
TITLE ST	MMARY OF TESTING:			mune	
	SISTANT FINISH FO			TURE	
	то				• .
0			.DATE		
SHORT TIT					
		•		•	
STIA HAY DISTRIBUTE THE	SPECIAL LIMITATI	ONS ON ASTIA DIS	TRIBUTION		
	S REPORT TO REQUESTING HE FOLLOWING:				PPR
X UNLIMITED - TO ALL	AGENCIES OF THE DEPARTM	ENT OF DEFENSE A	ND THE IS COUTDAGE		•
LIMITED - TO U.S. M	ILITARY ORGANIZATIONS OF	DEFERSE A	NO THEIR CONTRACT	rors.	
HIS REPORT MAY BE DISTR	BUTED TO NORMILITARY A	GENCIES NAT ABBR			
	BUTED TO NONMILITARY A	GENCIES NOT APPR			
OTE: THE LIMITED CATEG	IBUTED TO NONMILITARY A	GENCIES NOT APPR			
	IBUTED TO NONMILITARY A	GENCIES NOT APPR			
OTE: THE LIMITED CATEG	IBUTED TO NONMILITARY A	GENCIES NOT APPR			
OTE: THE LIMITED CATEG	IBUTED TO NONMILITARY A	GENCIES NOT APPR			
OTE: THE LIMITED CATEG	IBUTED TO NONMILITARY A	GENCIES NOT APPR			
TE: THE LIMITED CATEG	IBUTED TO NONMILITARY A	BECAUSE OF ACTU			
TE: THE LIMITED CATEG	IBUTED TO NONMILITARY AND ORY MAY BE CHECKED ONLY AR IMPLICATIONS.	BECAUSE OF ACTU	AT OR POTENTIAL F

INTRODUCTION

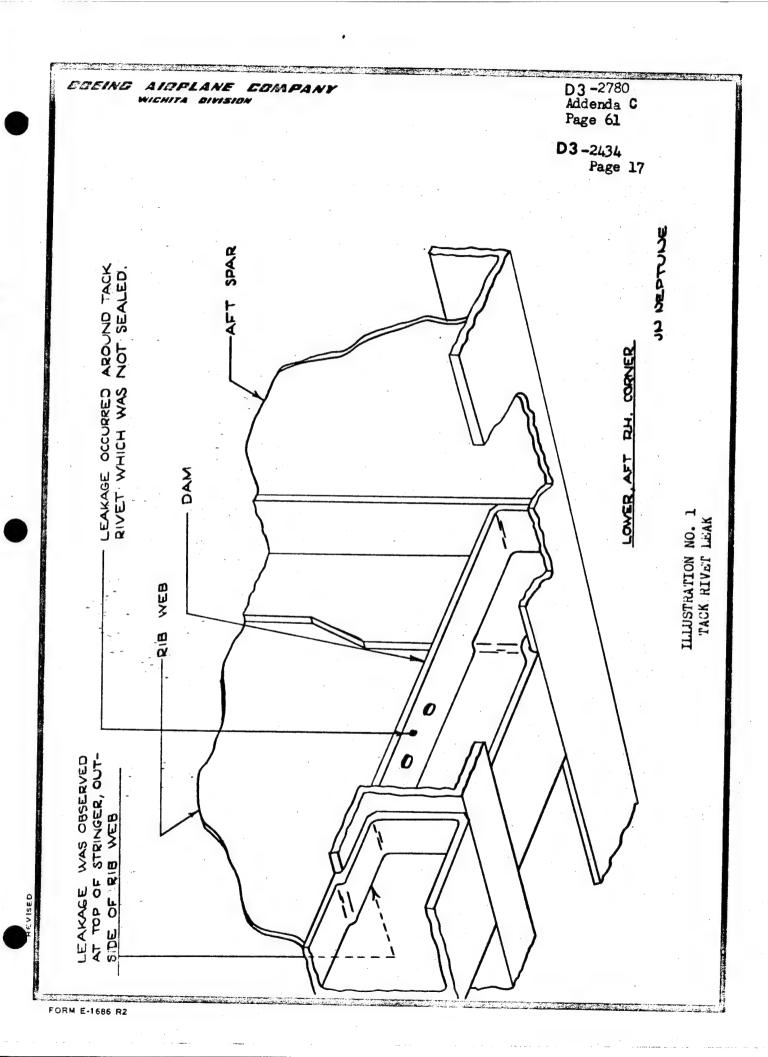
D3-2780 Addenda C Page 62 BEEING AIRPLANE WICHITA DIVISION **D3** -2434 Page 18 JU DEPTUNE OCCURRED AROUND BOLT AND WAS OUTSIDE THE CUBE AT TOP OF STRINGER ILLUSTRATION NO. 2 AN BOLT LEAK RIB WEB LEAKAGE O LOWER, AFT L.H. CORNER AFT SPAR

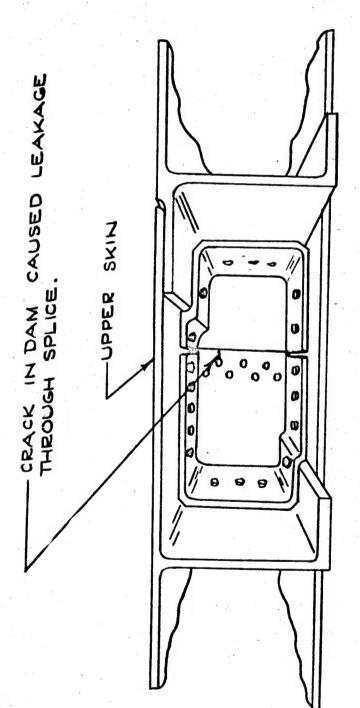
MIDDLE DAM UPPER LH. SIDE

ILLUSTRATION NO. 3 CRACK IN FUEL DAM COSING AIRPLANE COMPANY
WIGHTA DIVISION

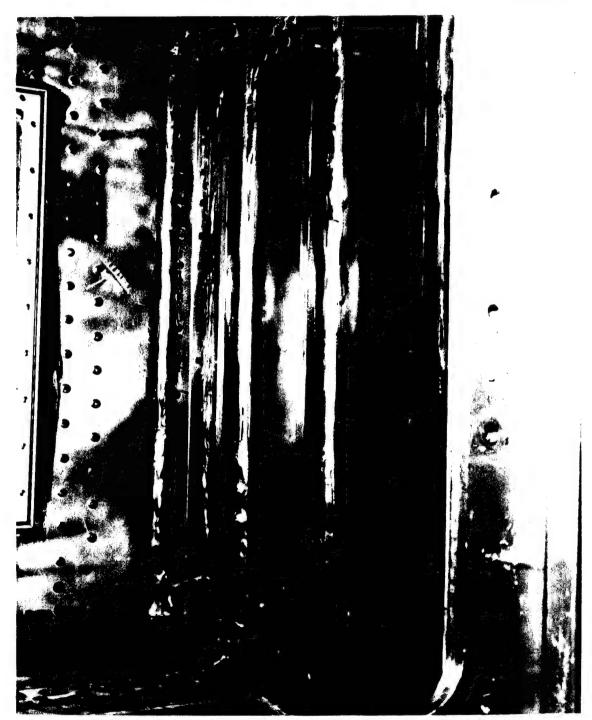
BW-134346

TEST CUBE NO. 1 RT FWD CORNER

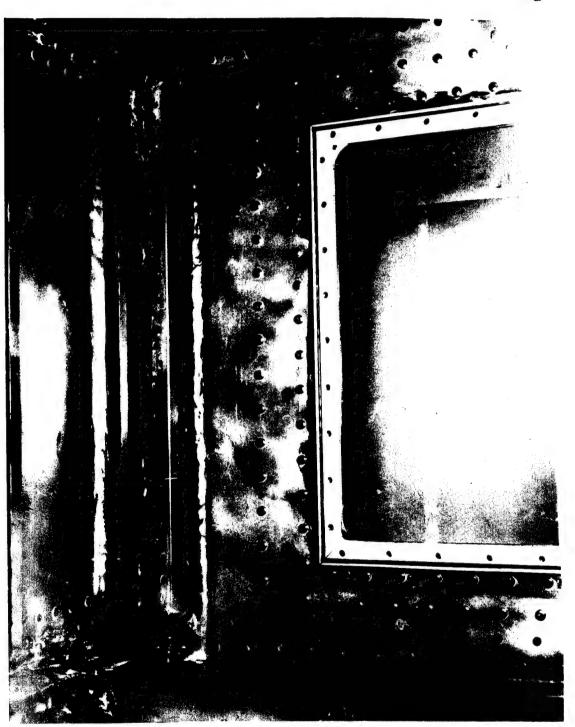
BW-134348

TEST CUBE NO. 1 LEFT FWD CORNER

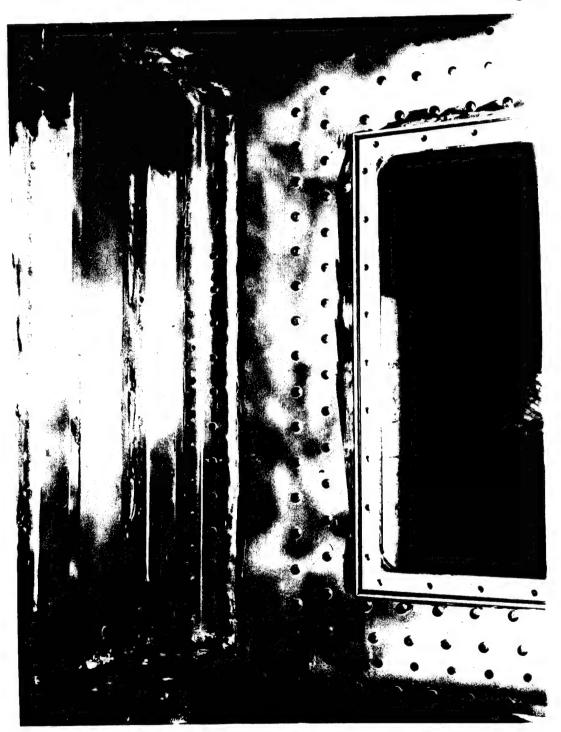
BW-134350

TEST CUBE NO. 1 RT AFT CORNER

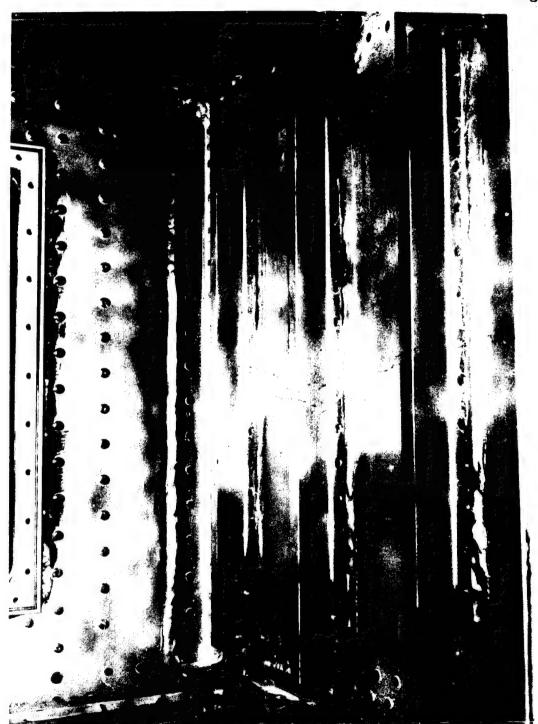
BW-134352

TEST CUBE NO. 1 LEFT AFT CORNER

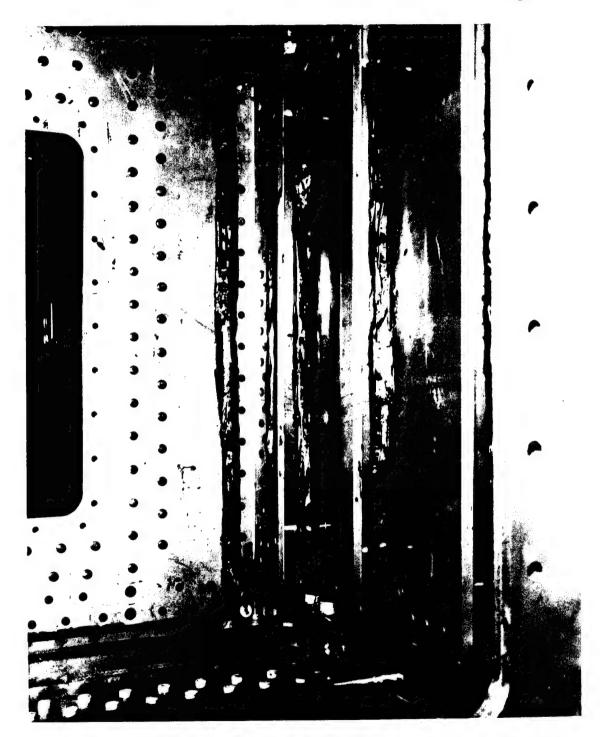
BW-134347

TEST CUBE NO. 2 FT FWD CORNER

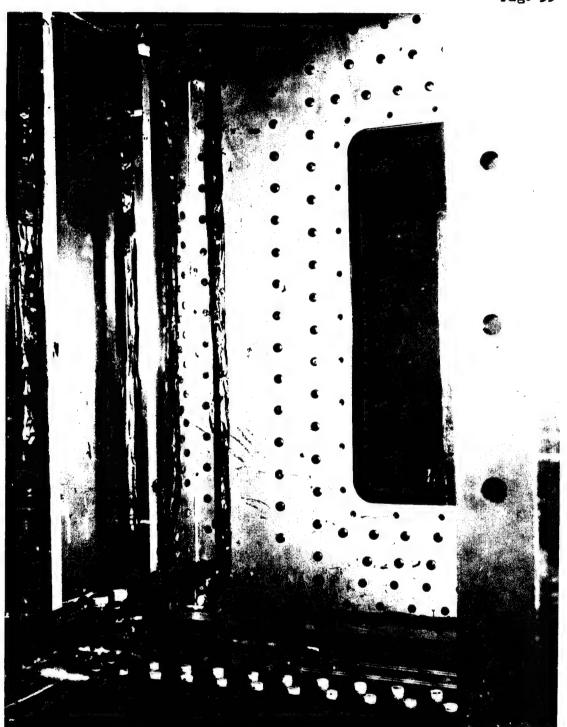
BW-134349

TEST CUBE NO. 2 LEFT FWD CORNER

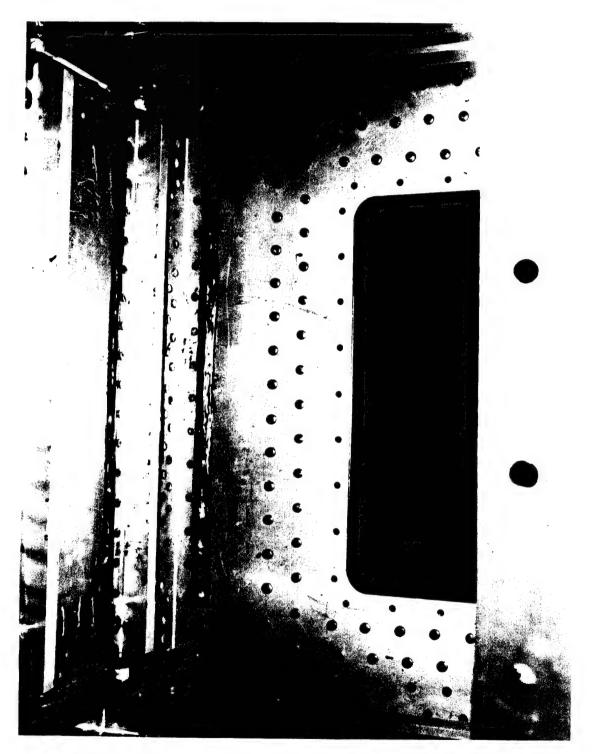
BW-134351

TEST CUBE NO. 2 RT AFT CORNER

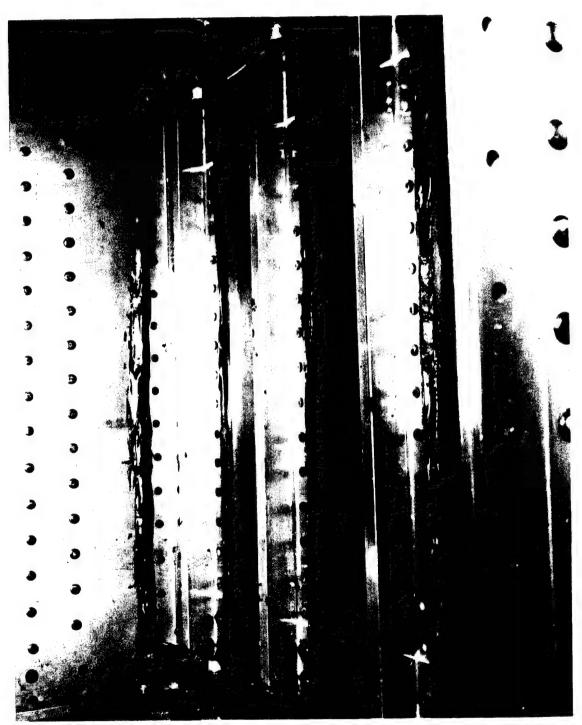
BW-134353

TEST CUBE NO. 2 LEFT AFT CORNER

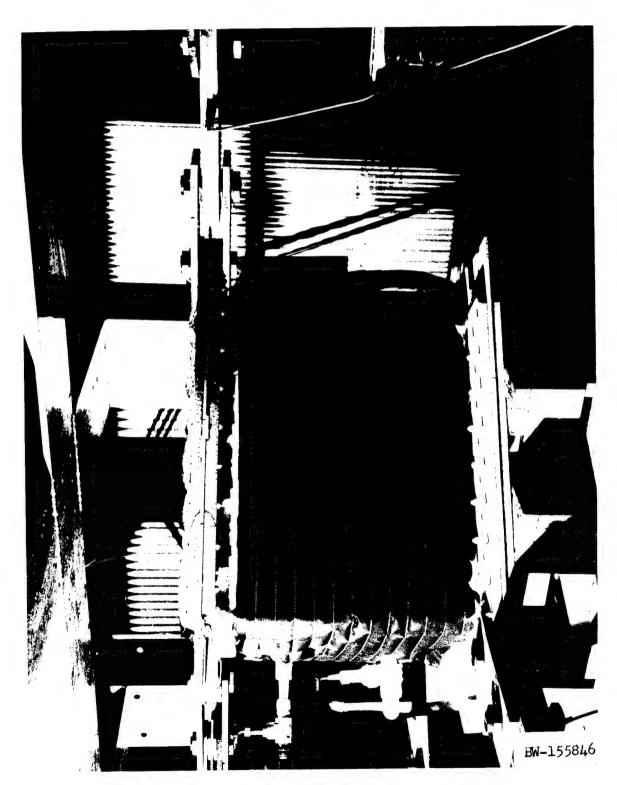
INBOARD END VIEW OF CUBE TO WHICH CAGES WERE APPLIED
